# CNG and Hydrogen Vehicle Fuel Tank Failure Incidents, Testing, and Preventive Measures

**Robert Zalosh**

## ABSTRACT

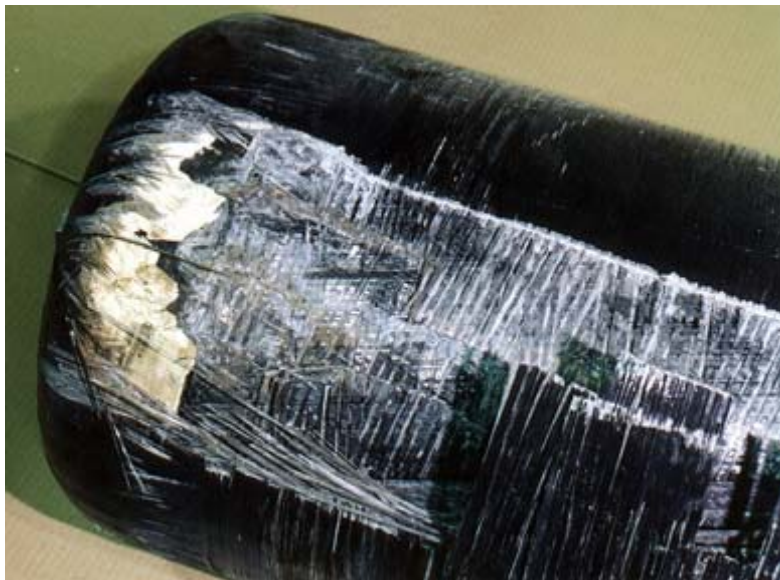
The relatively small number of CNG cylinder failures is remarkable in view of the field abuse to which vehicle installed cylinders have been subjected. Newhouse et al. (6) report that their company's Type 3 cylinders had not experienced a rupture as of 2002 despite numerous crash, impact, and vehicle fire incidents. The incidents described by Newhouse et al. include CNG tanks striking a bridge with a force that sheared off part of the structural support wrap as shown in Figure 3. Even with this damage, subsequent burst pressure testing revealed that the degraded tank could satisfy the FMVSS 304 burst pressure requirements for a new tank.

Figure 3 Type 3 cylinder damaged by bridge impact (from Newhouse et al.)

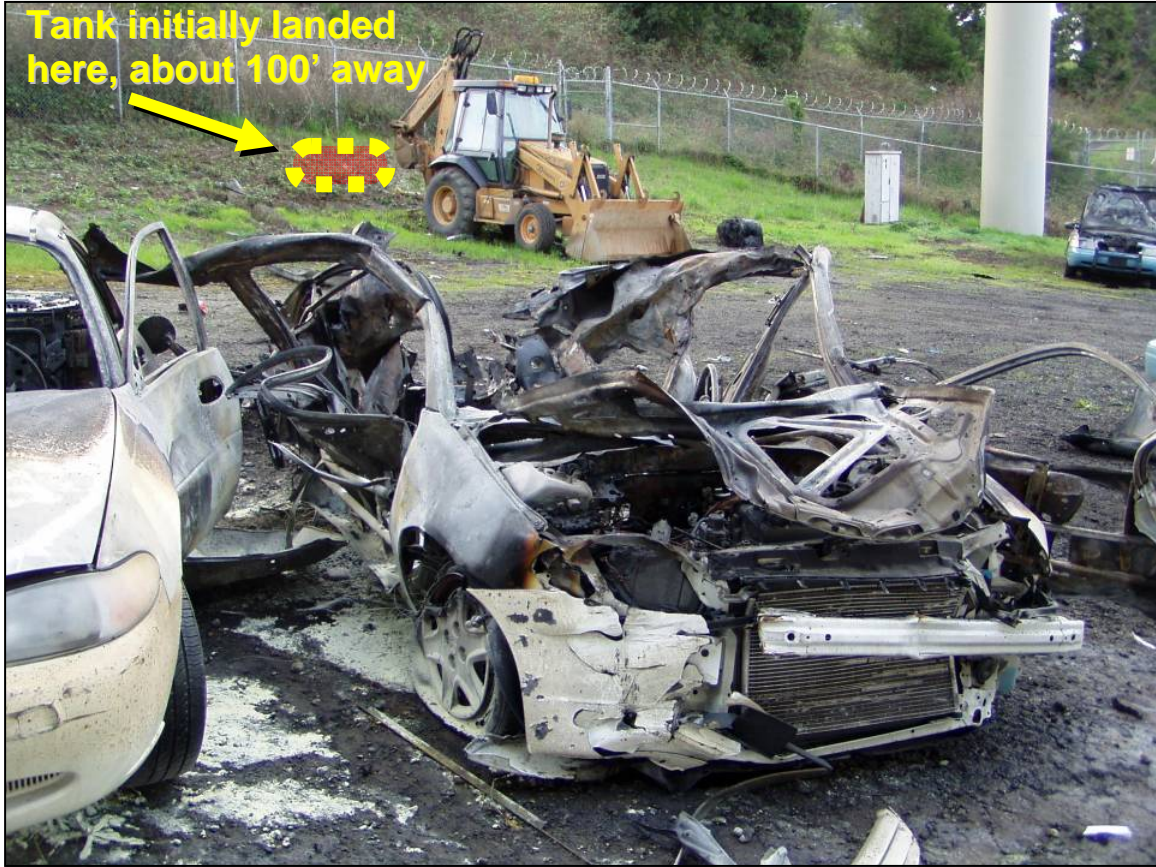
A similar incident occurred in a CNG fueled Honda Civic in Seattle in March 2007. According to the Seattle Fire Department (13), an arsonist set fire to a row of parked vehicles in an outdoor lot. Seattle firefighters responding to the fire were 50 to 75 ft (15 to 23 m) away from the Honda and approaching it with a handline when the CNG tank exploded and rocketed. Figure 6 shows the burned remains of the Honda Civic, and Figure 7 shows the remains of the Type 4 CNG tank about 100 ft away from the Honda. Other large debris from the Honda was found 75 to 90 ft (23 to 27 m) away from the vehicle. Fortunately, nobody was injured in this incident. Since this incident, the fire NHTSA and Honda investigations have led to Honda installing insulators between the back seat and the CNG tank (NHTSA Action Number: PE07028), as Ford did with the CNG fueled Crown Victoria.

Figure 6. Remains of Honda CNG vehicle from March 2007 fire in Seattle.

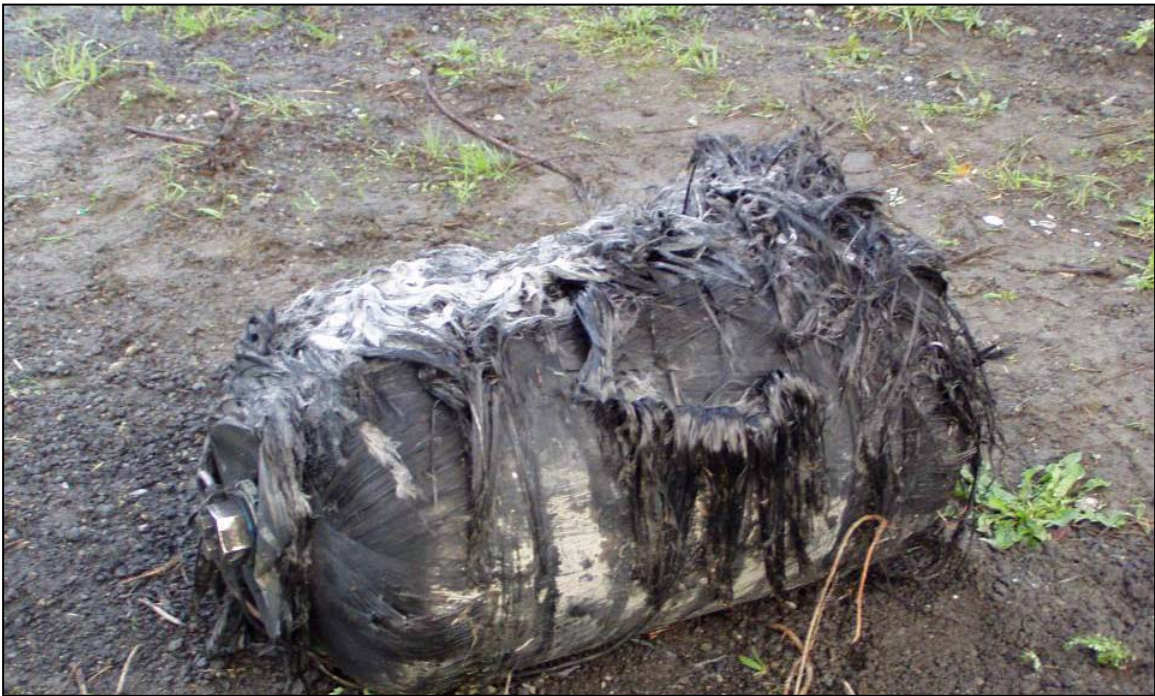
Figure 7. Ruptured cylinder remains from Honda Civic GX fire in Seattle.

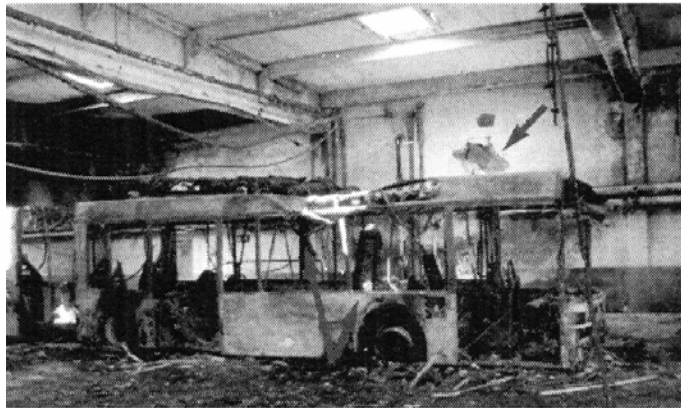
Perrette and Wiedemann (14) describe three fire induced CNG cylinder failures aboard buses in Germany and France. CNG cylinders in Europe are qualified in part based on the same type of bonfire exposure test required by FMVSS 304 and NGV2. The failed CNG cylinder in Germany was a PRD protected Type 3 cylinder with a fill volume of 172 liters and a fill pressure of 200 bar (2900 psi). An engine fire starting in one articulated bus spread to a second bus in a depot, resulting in fire exposure to a total of 20 roof mounted CNG

cylinders. The double PRDs on all but one of the cylinders actuated at or around their 110°C actuation temperature. The 20<sup>th</sup> tank ruptured about 15 minutes after the fire started. The ruptured tank rocketed through the depot wall, leaving the hole and charred bus shown in Figure 8. The inside of the un-actuated PRD is shown in Figure 9.

**Figure 8 Burned CNG bus with arrow pointing to hole in depot wall (from Perrette and Wiedemann)**

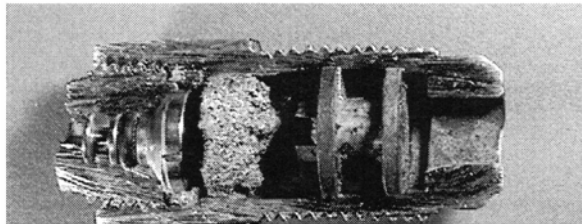
**Figure 8 Un-actuated PRD on bus cylinder that ruptured (from Perrette and Wiedemann)**

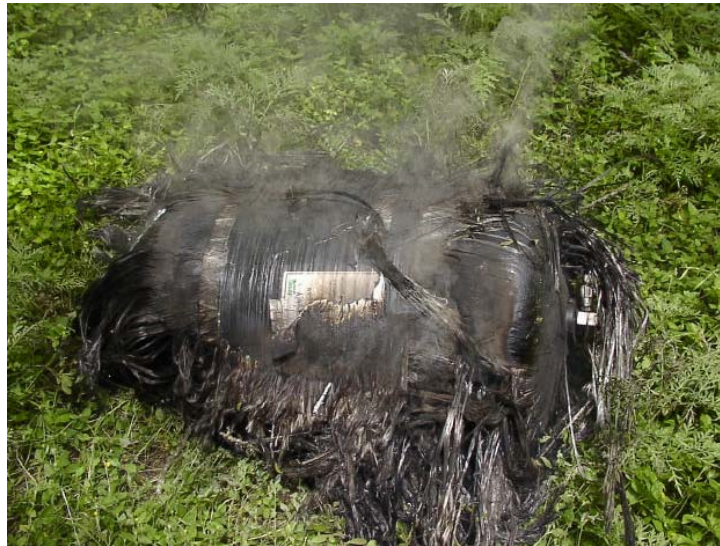
The Type 4 hydrogen cylinder primary remains were found about 82 m away from the burner. The largest fragment of the Type 3 hydrogen cylinder was found about 41 m away from the burner. These fragments are shown in Figures 12a and 12b. Note the similarity to the ruptured Type 4 CNG cylinder from the Seattle fire (Figure 7). SUV fragments from the second test were found at distances up to 107 m away from the original SUV location.

**Figure 12a Type 4 hydrogen cylinder fragment (from Zalosh)**

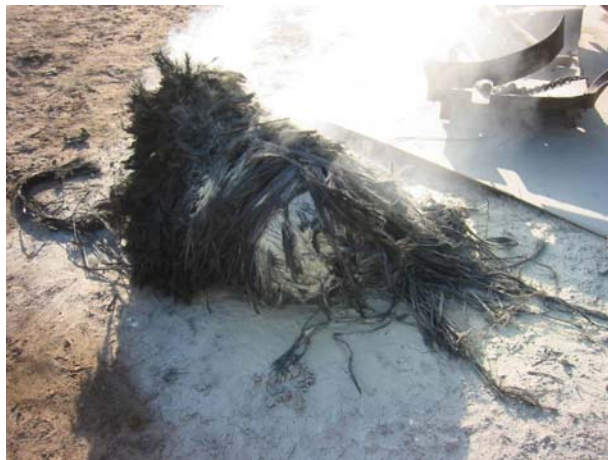
**Figure 12b Type 3 hydrogen cylinder fragment (from Zalosh)**
