# CNG and Hydrogen Vehicle Fuel Tank Failure Incidents, Testing, and Preventive Measures

**Robert Zalosh**

## ABSTRACT

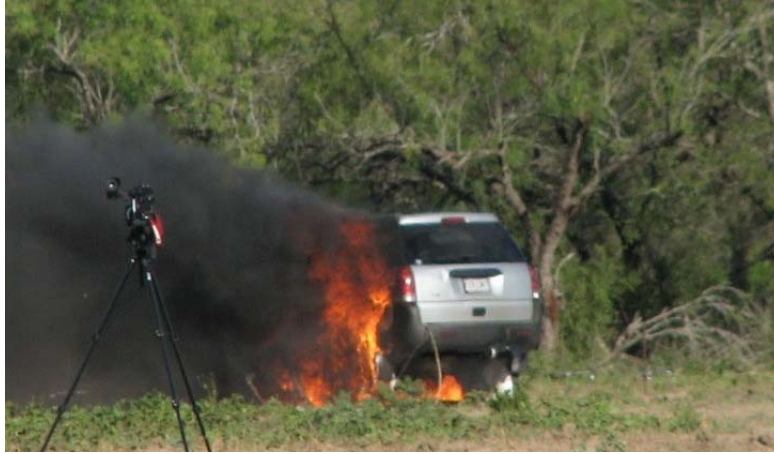
**Figure 11 Fire 9 minutes after ignition under hydrogen cylinder (from Zalosh)**

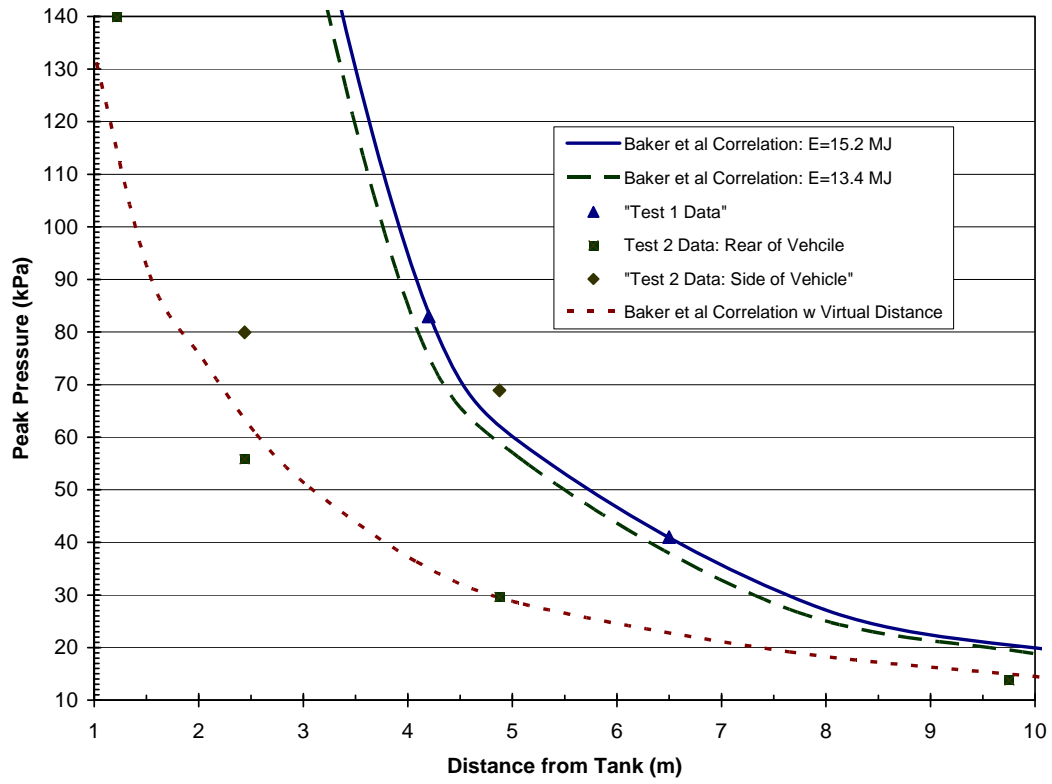
Representative blast pressures measured in both tests are shown in Figure 13. The ideal blast wave pressures calculated for blast energies of 13 MJ and 15 MJ are also shown in Figure 13. The blast energies were calculated from hydrogen isothermal expansion from the

tank rupture pressure as described by Zalosh (16). The agreement with the data demonstrates the viability of blast wave calculations based on the cylinder pressure and volume.

Figure 13 Cylinder blast wave pressures versus distance from cylinder (from Zalosh)
